RE: Reclamation Plan, Topaz Mining Property, Brush Wellman Inc., ACT/023/003, Juab County, Utah

This report is to document my assignment - recommending a possible revegetation procedure for subject mine tuff-covered dump areas. This assignment was made with the understanding that it is too late to move the existing tuff-covered materials to a pit or haul in topsoil as it had been presumed several years ago that the tuff material would be acceptable.

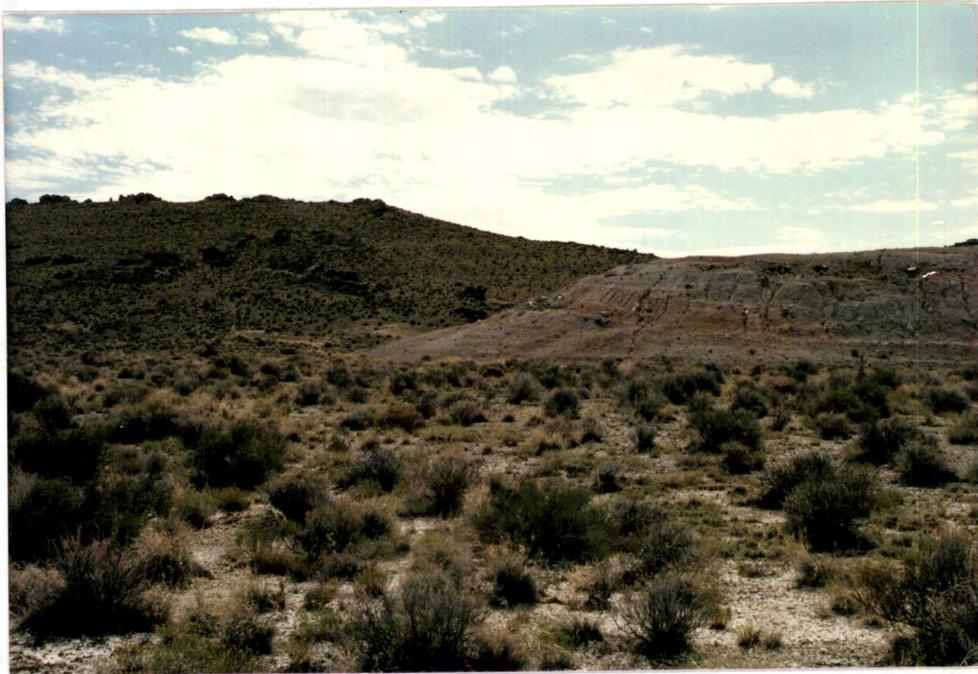
The mine is in a six- to eight-inch rainfall area with browse species dominating the vegetative cover. Species in the area include: black sagebrush, Mormon-tea, horsebrush, broom snakeweed, shadscale, fourwing saltbush, and rabbitbrush. Grasses include Indian ricegrass and galleta. A mine dump can be seen at the right side of the photograph.

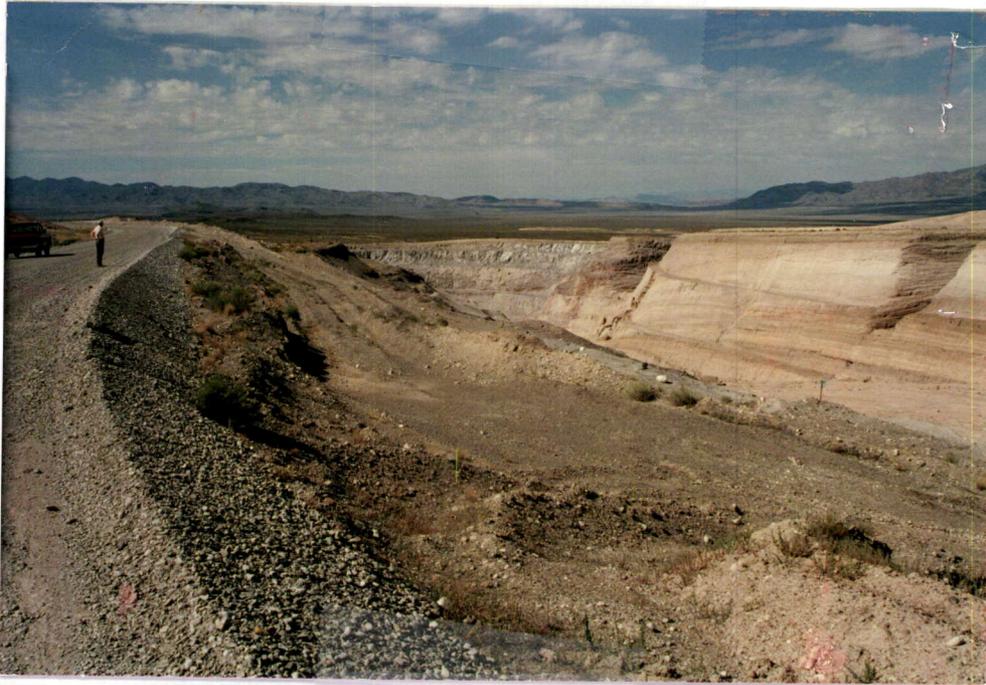
Roadside Mine Area - This pit is being filled as mining progresses.

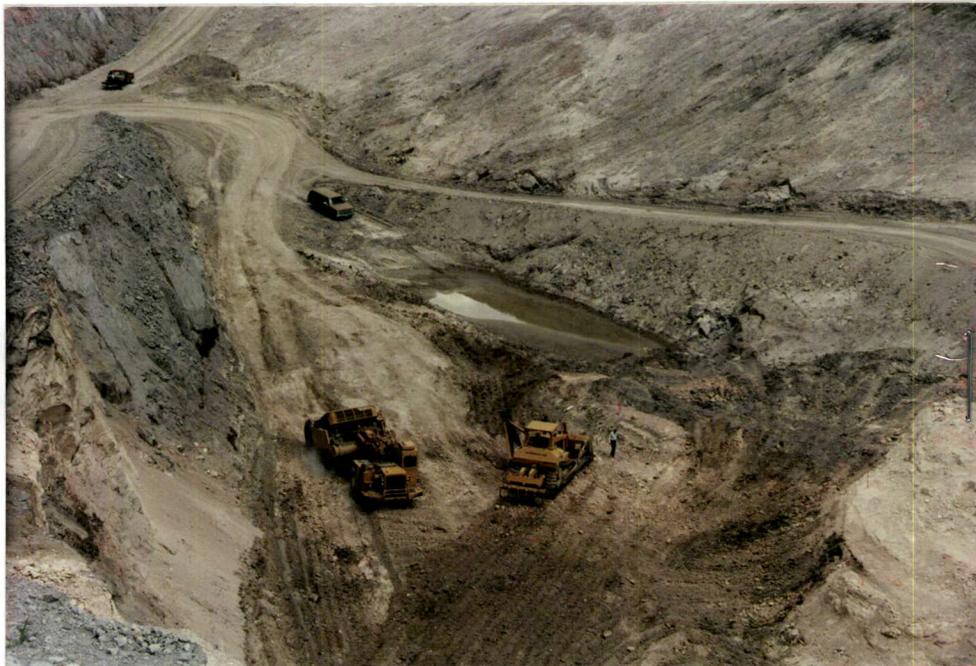
Blue Chalk Mine - (Note the tractor with six rippers - an ideal tool for seedbed preparation.)

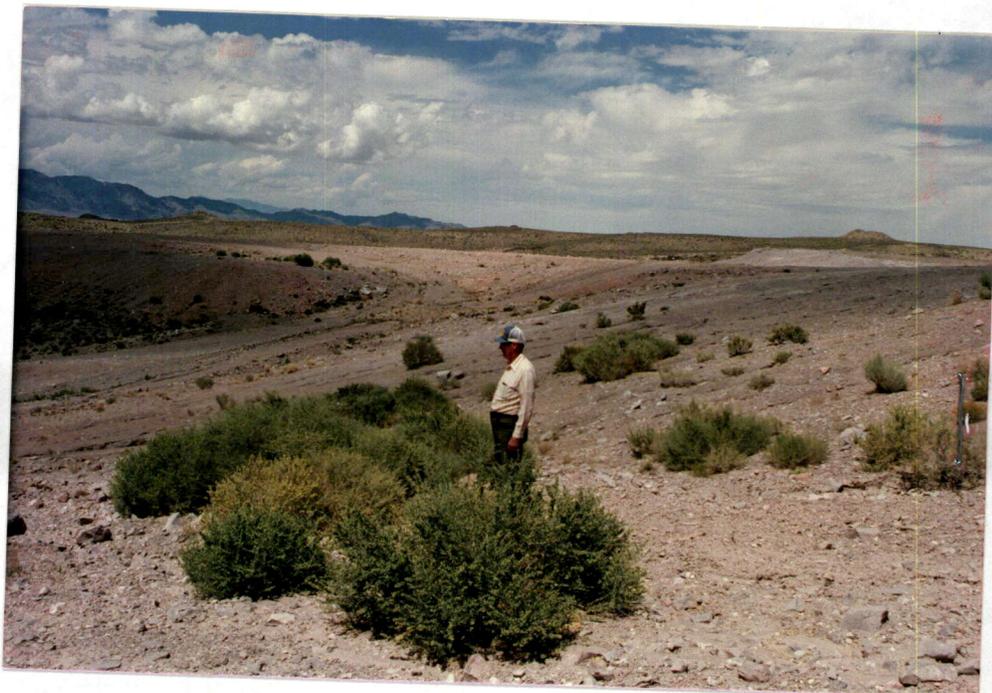
Test Plot - showing several very vigorous fourwing saltbush plants. Note there is overland flow of precipitation. Future seedings could check this with small pits or contour furrows thus providing more moisture for plant growth. (Lee Davis in photograph)

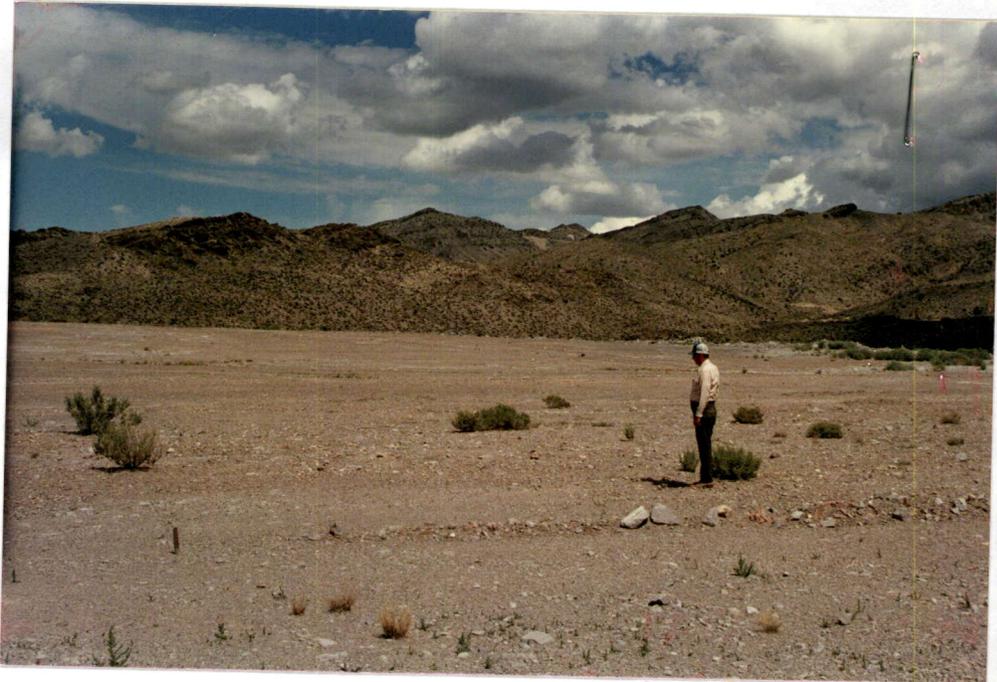
Test Plot - showing sparse fourwing saltbush plants, however, there is a large amount of run off of the limited precipitation. A pitted surface could check the runoff and provide moisture for additional plant growth.

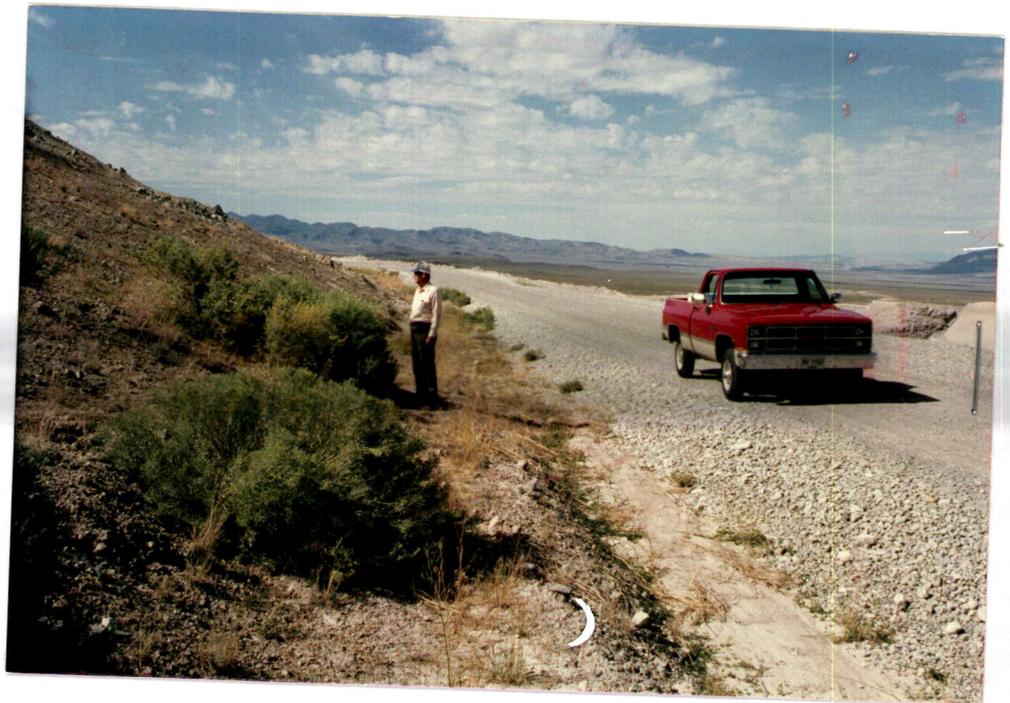
Test Plot - showing very vigorous fourwing saltbush plants, grass, and yellow sweet clover.

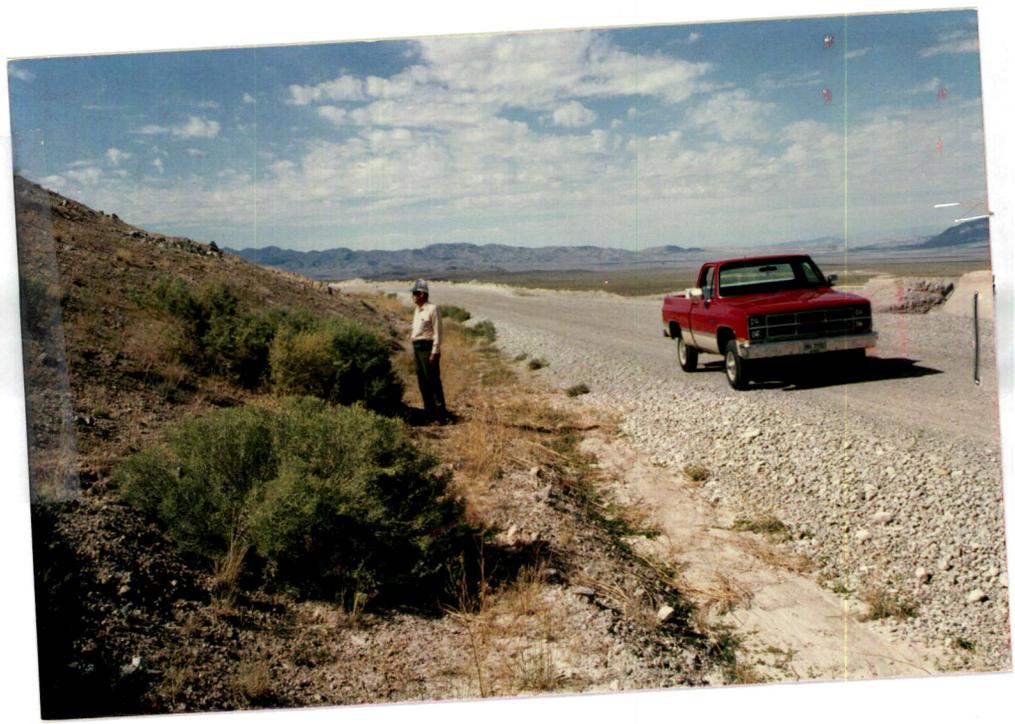
Test Plot - showing very vigorous fourwing saltbush plants, grass, and yellow sweet clover.

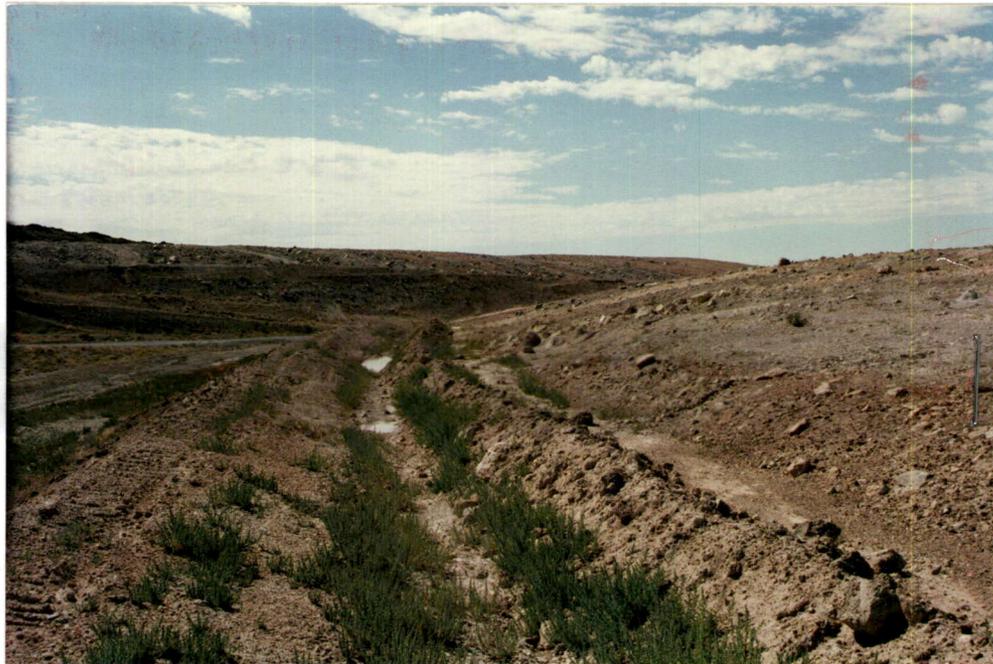
Contour Furrow - constructed in the fall of 1986. It wasn't seeded, however, it is catching precipitation which would provide for desirable plant growth. The plants are halogeton.

Pitting or contour furrows like this one (with the addition of baffles approximately 25 feet apart) across the dump areas appear to be the best way to trap the limited precipitation for plant growth.

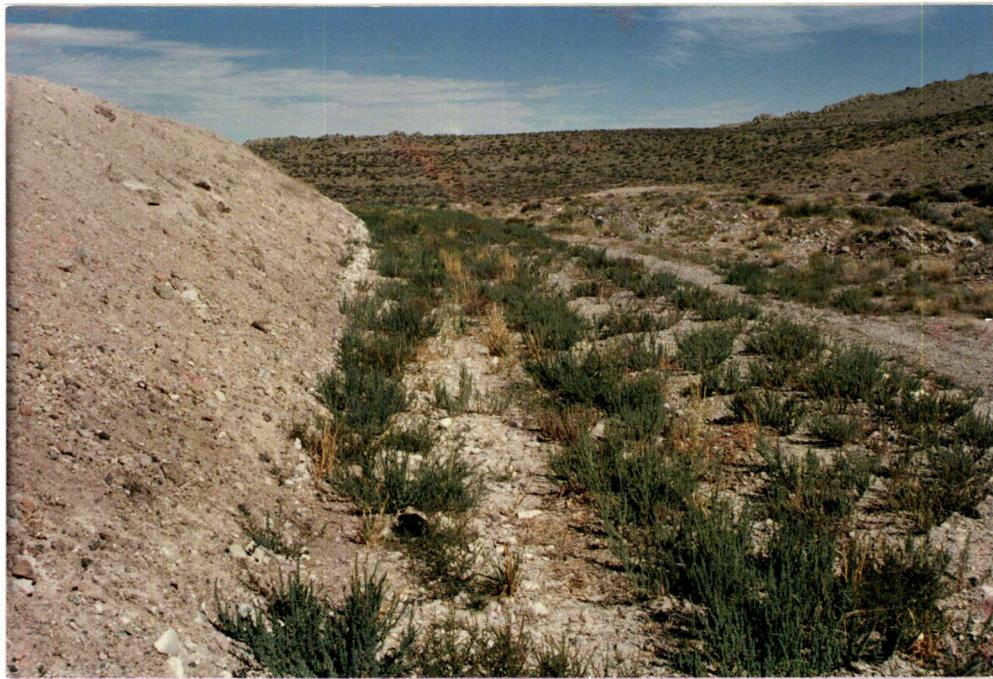
Contour Furrow - constructed in fall of 1986. It was straw mulched and seeded. There is quite a bit of weed growth including halogeton, but there is also some seeded species growing.

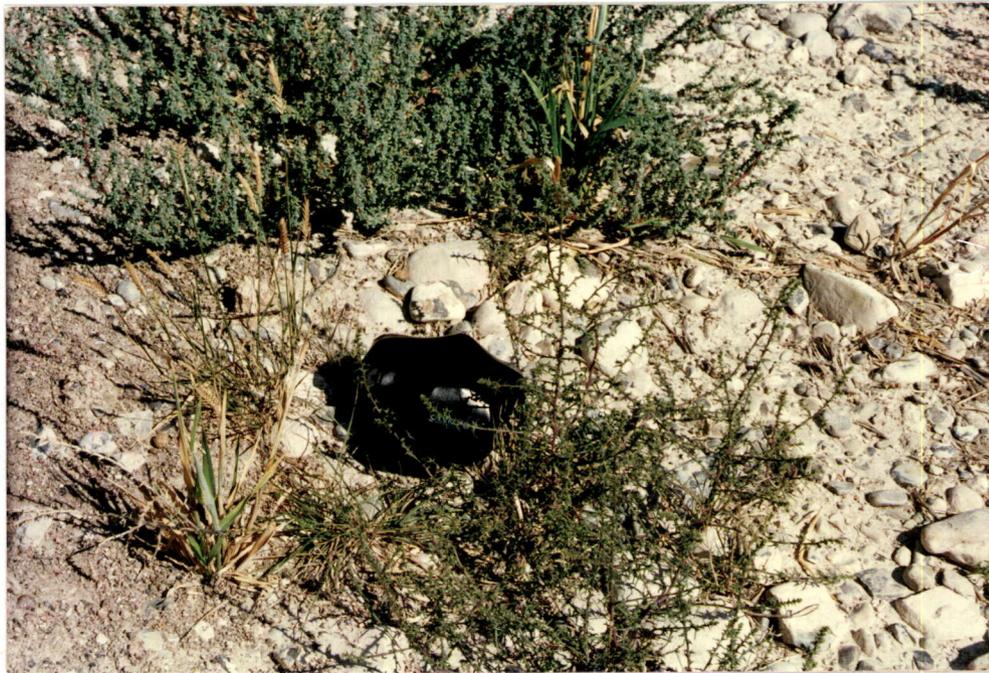
Close up of above photo. (Note: a crested wheatgrass plant has made seedhead in less than a year.)

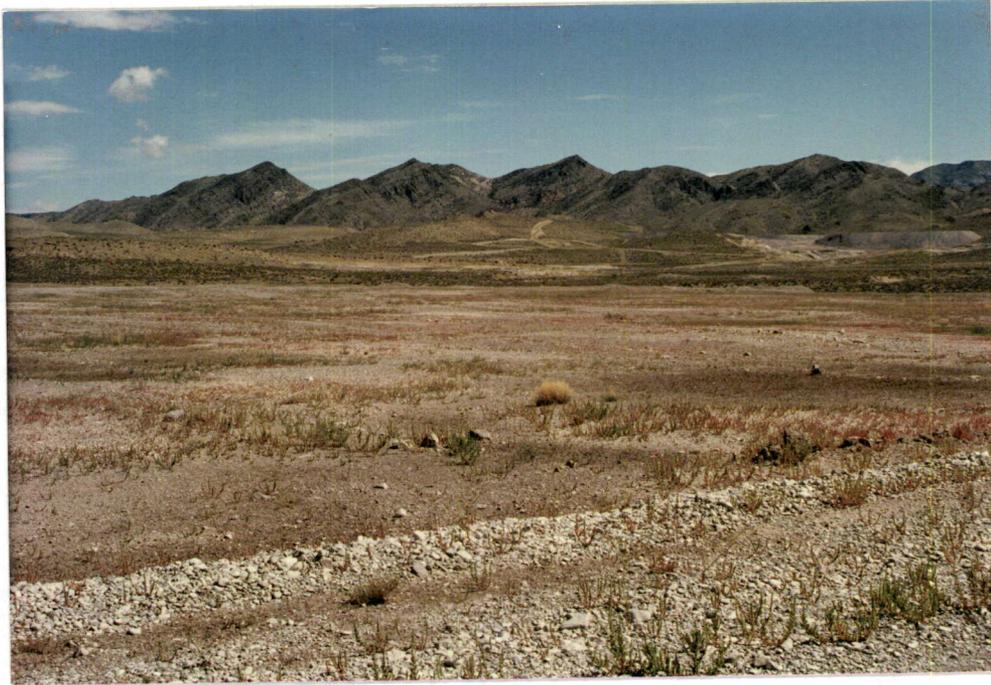
Top portion of one of the dump areas. A "lonely" Indian ricegrass plant has established itself among the halogeton. Some of these dump areas appear to be less harsh than others. Revegetation may or may not be possible; however, it should be tried - with an emphasis on getting browse species established to provide maximum ground cover and add some green vegetative growth to the landscape.

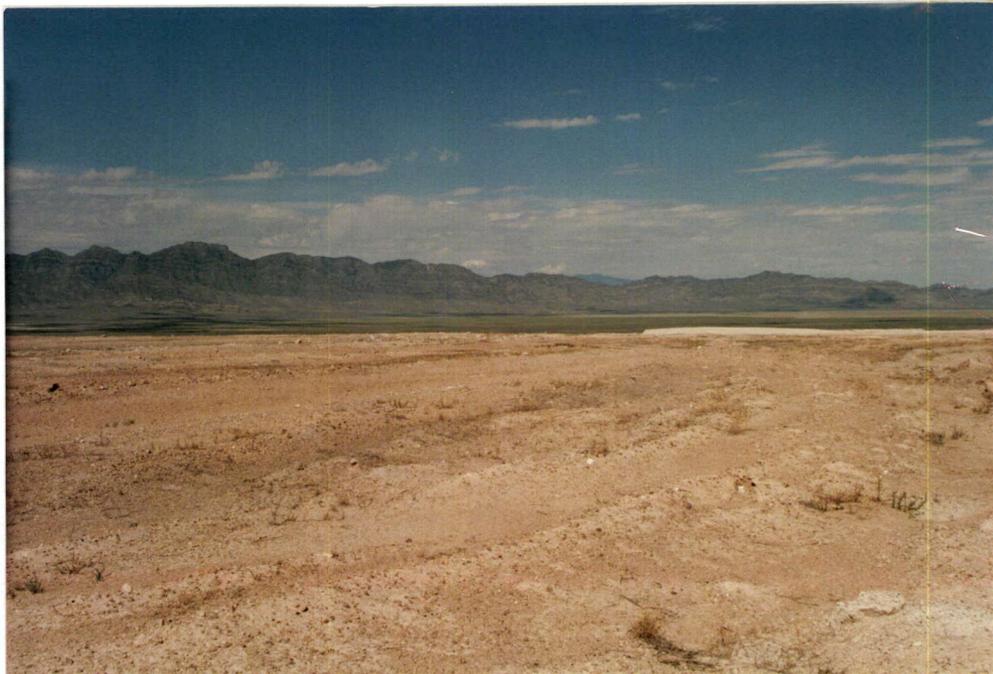
Another dump area - appears to be more harsh than the area above.
